Follow-up Report of Demonstration Work of AR2000 Super Recycler

Green ARM Co., Ltd.
and
Nippon Hodo Co., Ltd.

This is a summary report on the results of the follow-up inspection conducted at the site of the road, which had been reconstructed by the AR2000 Super Recycler, a hot-in-place surface recycling machinery, and has been in service for approximately one year.

Inspected Date: December 17, 2002
 Repavement Date: November, 2001 (utilized about one year)
 Inspected Road: Ohgishima Plant Road, NKK
 1-1 Ohgishima, Tsurumi-ku, Yokohama
 Inspected Sites: Job Site #1-448m, Job Site #2 -449m, Inspected Width-6m

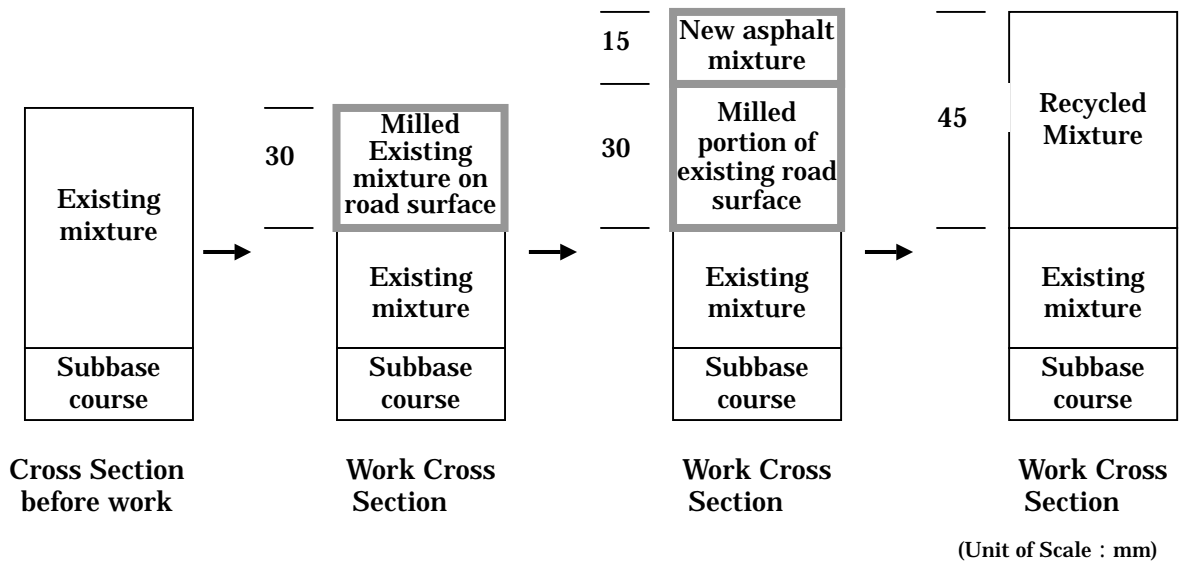
Figure-2.1 Work Cross Section (Surface Recycling in-place (remixing system))

The work method applied by the AR2000 was the so-called surface recycling in-place method (remixing system). A cross section of the performed demonstration work is shown in Figure 2.1.

- Work Cross Section Heating and milling of existing mixture
 - Work Cross Section Adding and placing of new material
 - Work Cross Section Mixing of existing mixture, new asphalt mixture and rejuvenator,
- Laydown
- Compaction

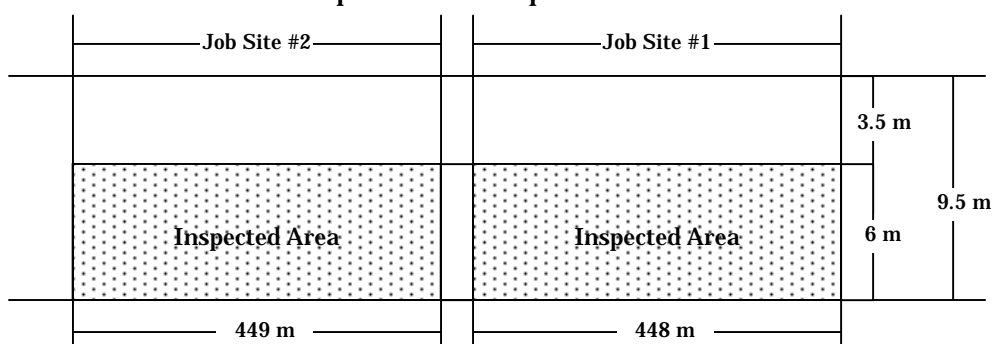
Chart 1: Inspected Sites

The chart below shows the inspected sites in plain view.

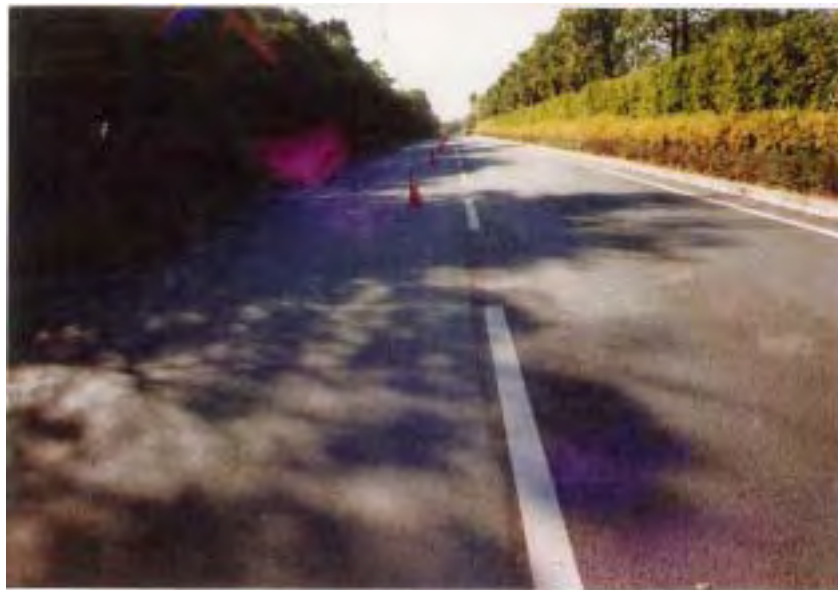
Photo-1 Job Site #1

A few places, where the aggregate was scattered on the road surface, were found at the job site #2, but not at #1. This was caused by a machinery trouble that had occurred during the operation. (Photos-1, 2, 3)

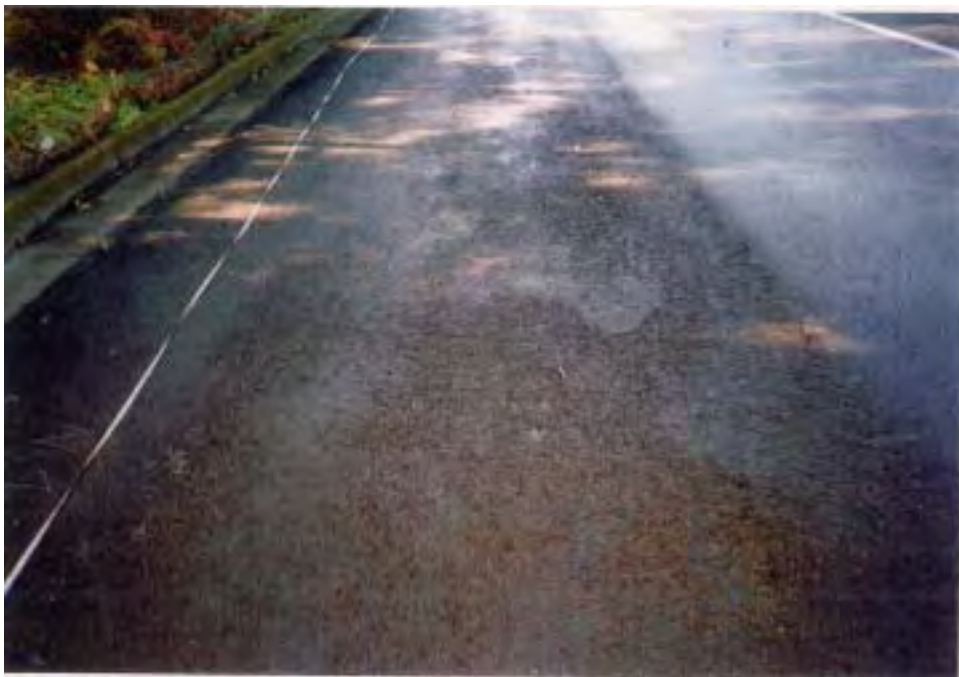
Photo-3 Aggregate scattering spots

There was a large spot of rutting caused by aggregate scattering, but the measured average values of 1.9mm at the job site #1 and 3.5mm at #2 can be concluded to be of no significant problem.

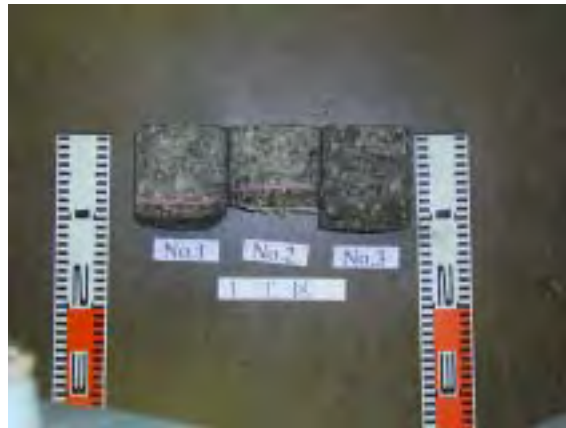
Job Site #1

3 pieces of core were sampled from each job site. In addition, 2 pieces of core from the aggregate scattering spots.

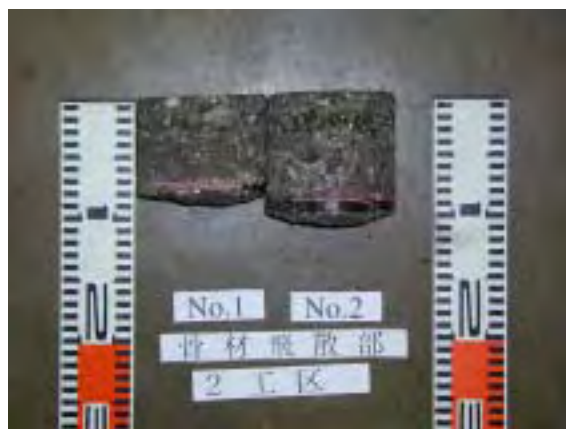
Aggregate scattering spots

The percentage of air voids obtained from the samples taken from the job site #2 was high, and rose higher at the aggregate scattering spots.

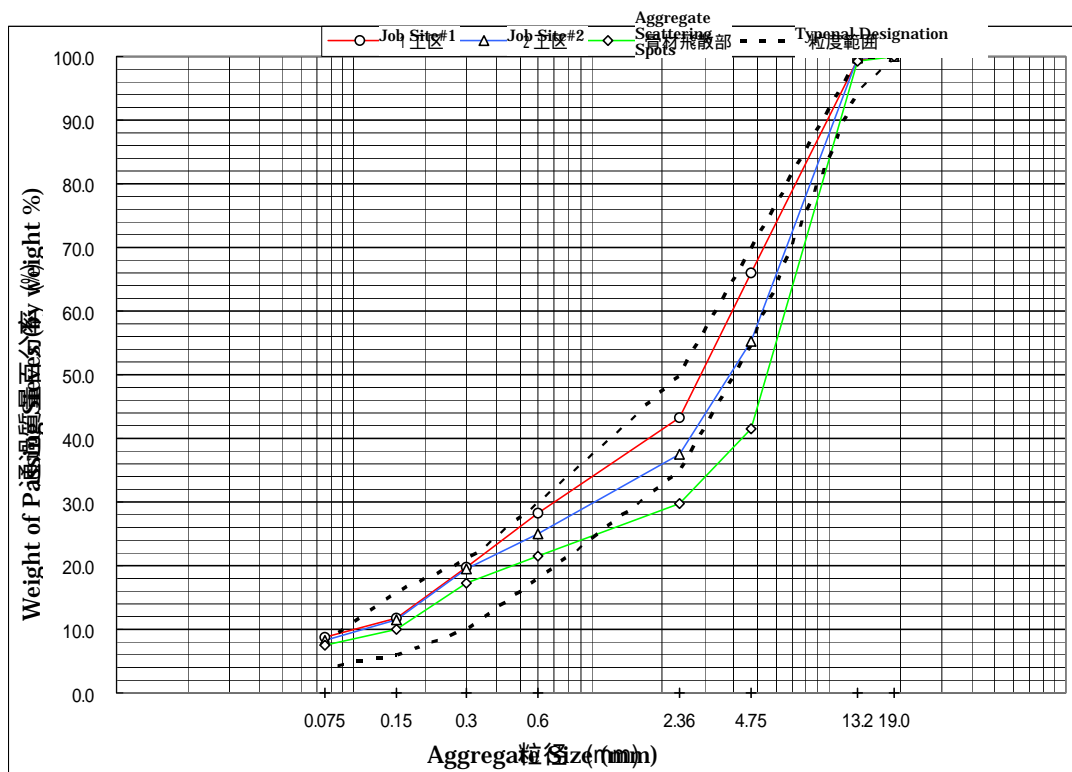
Chart-2: Grading Curves

The results of the test concluded that each extracted grade of the job site #1 and #2 was within the targeted gradation. Each grade sampled from the job site #1, however, was slightly finer since the weight percentage of the sieved fraction showed 1 to 3% larger than the mix design. As for the job site #2, the weight percentage of the fraction passing through 4.75mm and 2.36mm was 5% smaller, and the grading tended to be coarser. Furthermore, on the aggregate scattering spots of the job site #2, the grading was coarser.

The extracted asphalt contents shown in Table 6 are smaller than designed asphalt contents. Especially on the aggregate scattering spots, the asphalt content was much smaller due to the scattering.

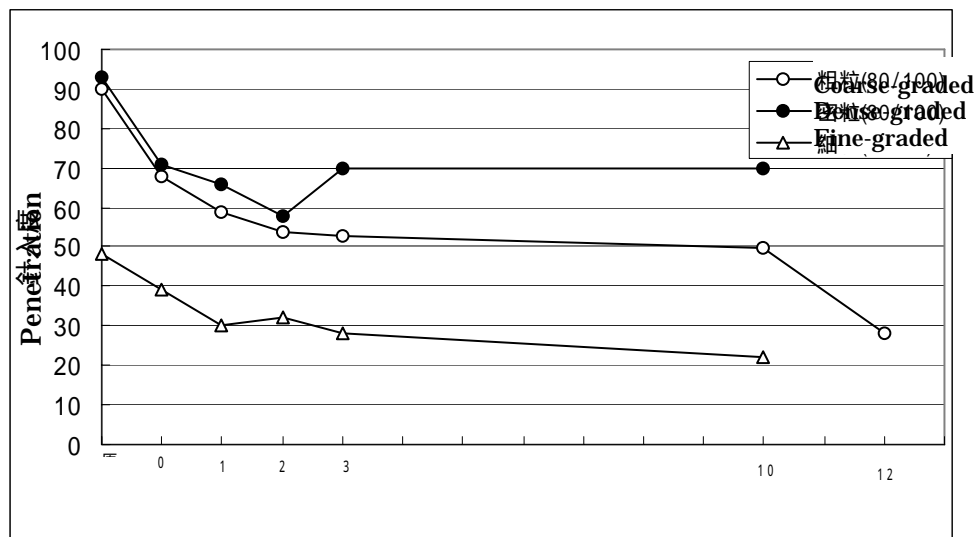
Chart-3: Penetration Curves of Utilized Mixtures

The characteristic test of the recovered asphalt concluded that the residual penetration at the job site #1 was 75.5% and 82.2% at #2. According to the retrospective records, asphalt deteriorates about 20% at the time of making and once utilized its deterioration reaches up to 60%. In comparison, the test concluded that the recovered asphalt had deteriorated more slowly than usual and no substantial deterioration was found.

It was, however, observed that the asphalt had deteriorated more quickly on the aggregate scattering spots at the job site #2 than the job site #1 and #2 (other parts of #2 than those aggregate scattering spots), as the residual penetration was measured 48.9%.

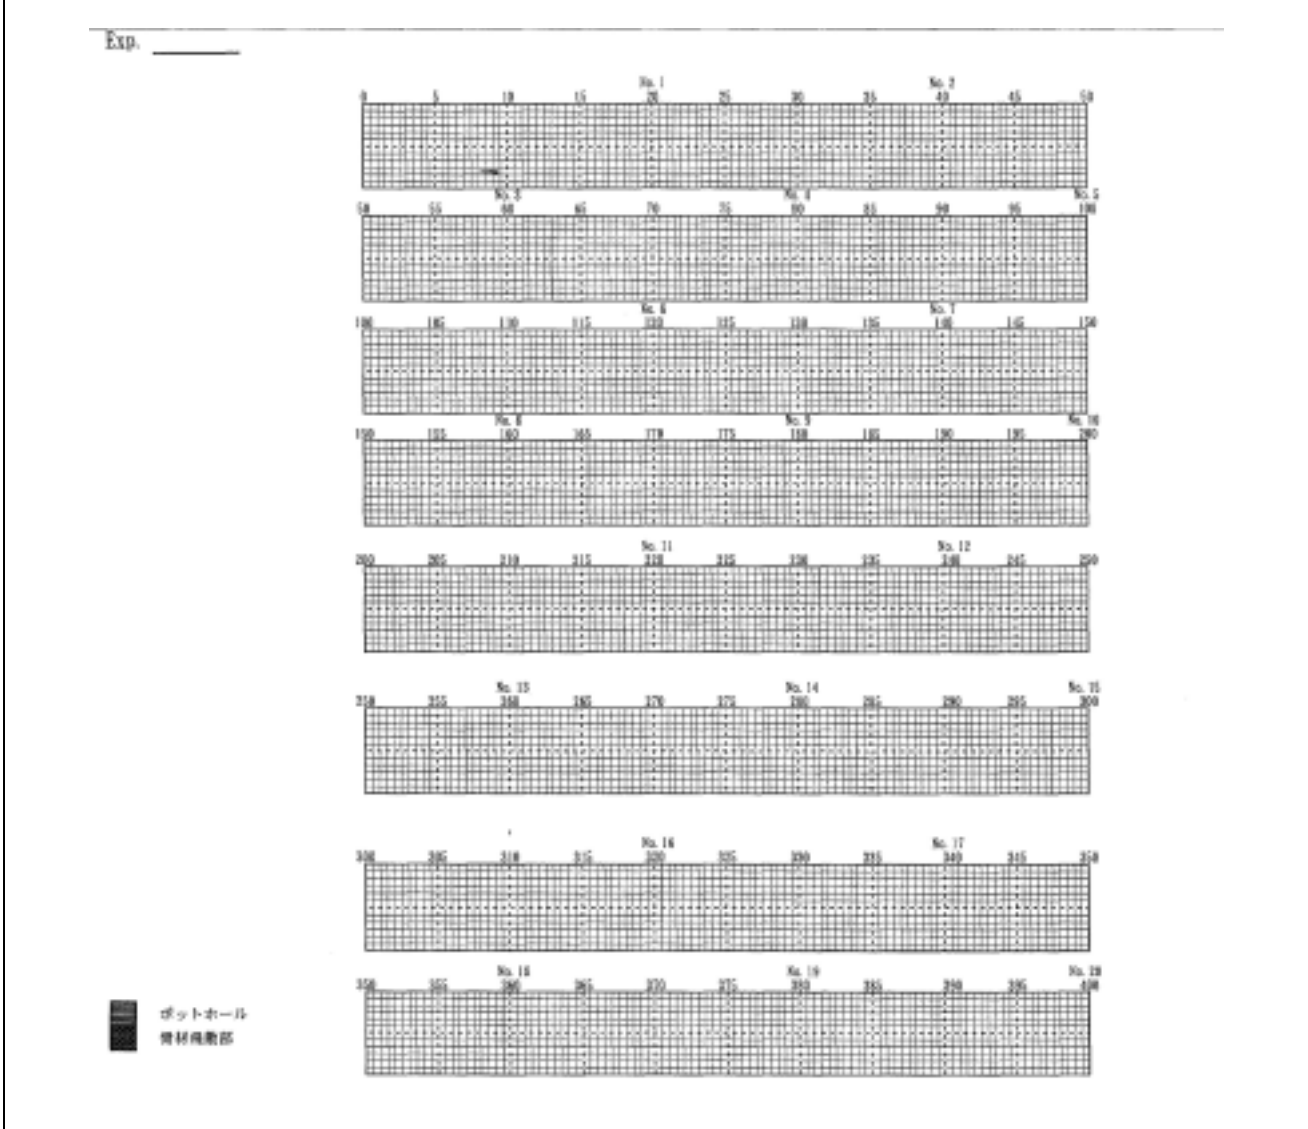
Road Surface Visual Inspection (Cracking Ratio)

Lane		Job Site	Work Section #1 Exp . ~ Exp .	Inspected Date	Dec.17 2001	Years in Service	1 year
Pavement Type	Dense-graded

A Grid with One Linear Crack	0 Grids	0.15m ² ×	0 Grids	= 0 m ²	Total Inspected Area	2688 m ²
A Grid with Two Linear Cracks	3 Grids	0.25m ² ×	3 Grids	= 0.75 m ²	Cracked Area	0.75 m ²
A Grid of Patching of 21% up to 75%	0 Grids	0.125m ² ×	0 Grids	= 0 m ²	Cracking Ratio = Cracked Area / Total Inspected Area	0.03 %
A Grid of Patching of 75% and More	0 Grids	0.25 m ² ×	0 Grids	= 0 m ²

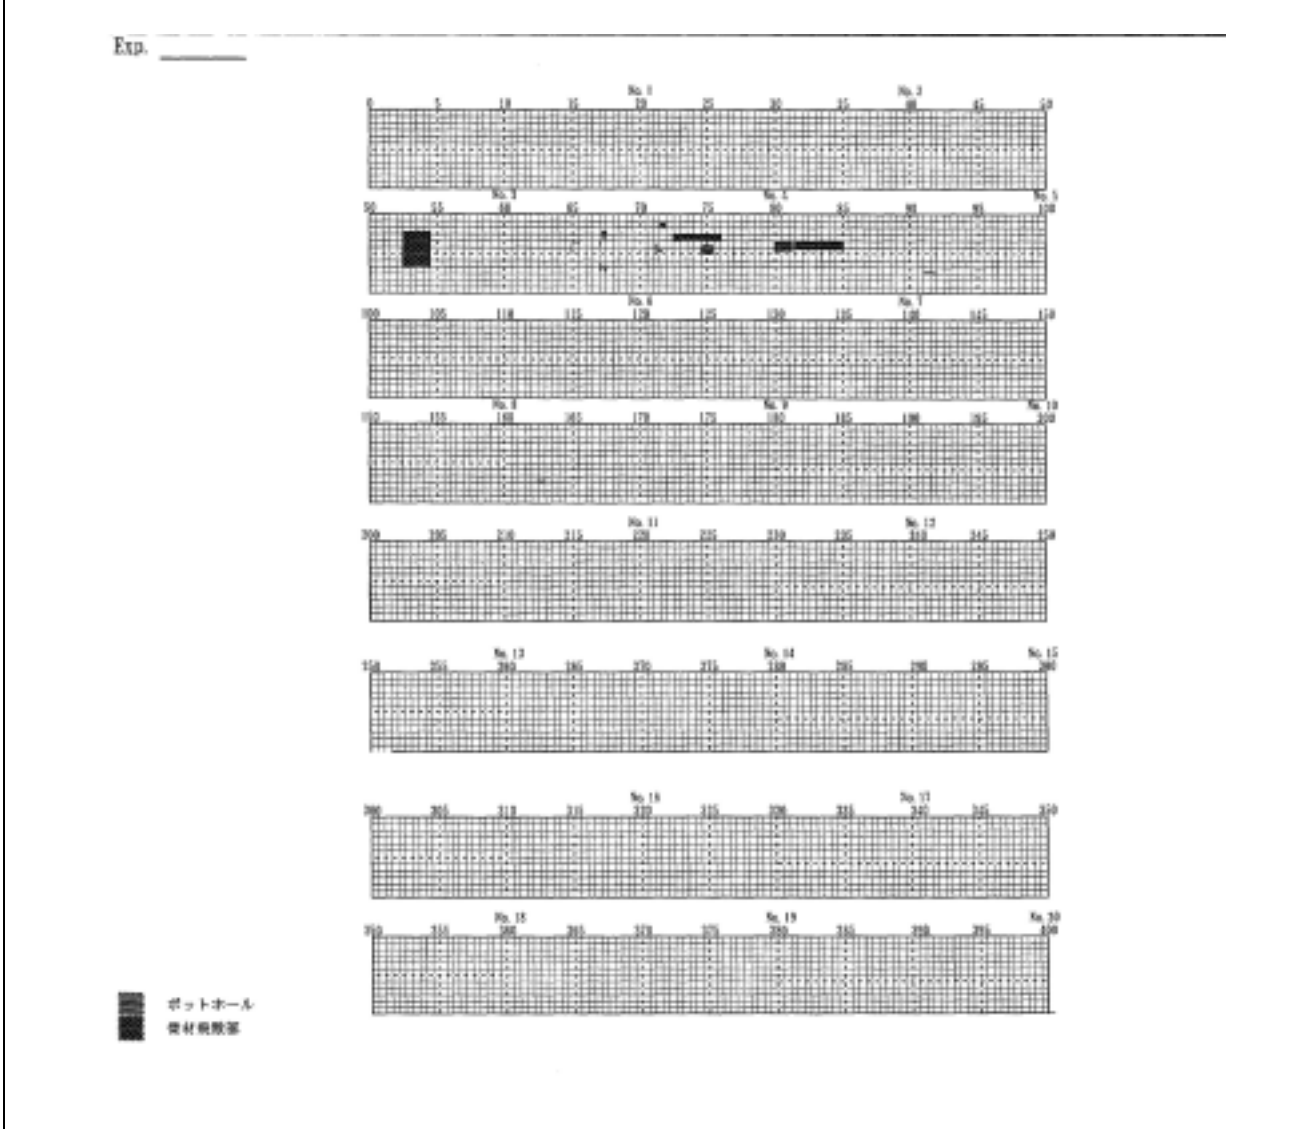
Road Surface Visual Inspection (Cracking Ratio)

Lane		Job Site	Work Section #2 Exp . ~ Exp .	Inspected Date	Dec.17 2001	Years in Service	1 year
Pavement Type	Dense-graded

A Grid with One Linear Crack	10 Grids	0.15m ² ×	0 Grids	= 1.5 m ²	Total Inspected Area	2688 m ²
A Grid with Two Linear Cracks	4 Grids	0.25m ² ×	3 Grids	= 1 m ²	Cracked Area	3.25 m ²
A Grid of Patching of 21% up to 75%	0 Grids	0.125m ² ×	0 Grids	= 0 m ²	Cracking Ratio = Cracked Area / Total Inspected Area	0.12 %
A Grid of Patching of 75% and More	3 Grids	0.25 m ² ×	0 Grids	= 0.75 m ²

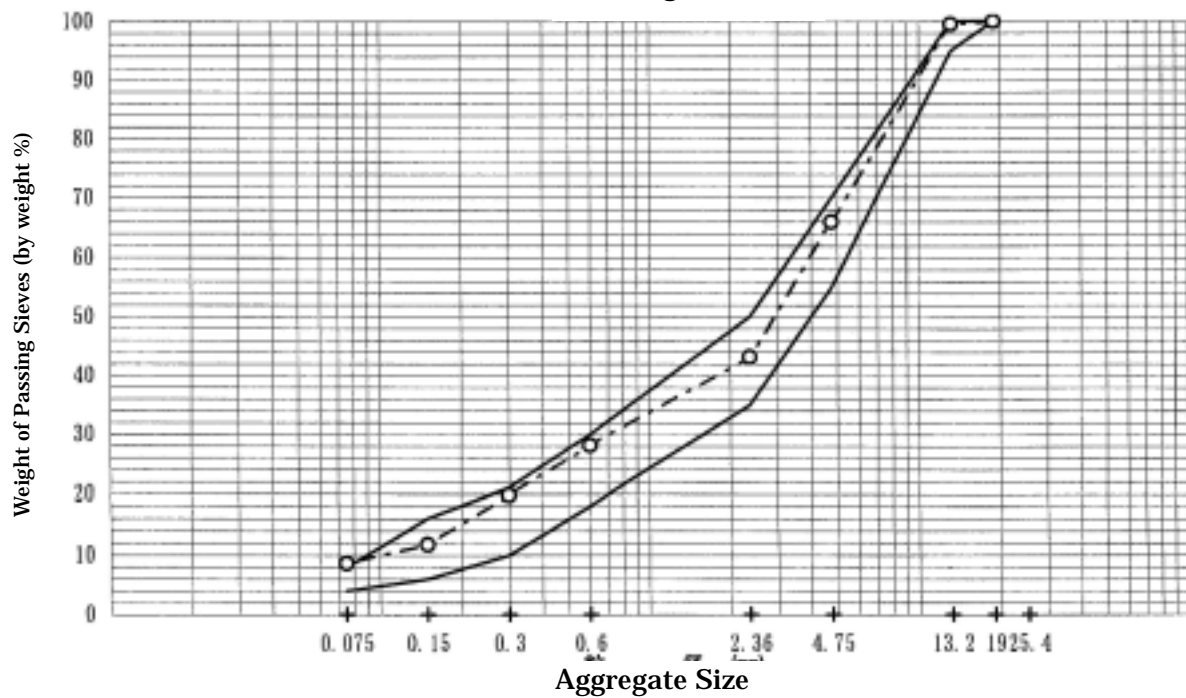
Grading Curves

Asphalt Content (%)			Sieving Analysis			
Weight of a Sample (g)	2500.0	Sieving Size	Accumulated Residual (g)	Accumulated Residual (%)	Passing (%)	
Weight of Extracted Aggregate (g)	2367.1	25 . 4mm				
Weight of Asphalt (g)	132.9	19 . 0	0	0	100	
Extracted Asphalt Content (%)	5.32	13.2	11.1	0.5	99.5	
Designed Asphalt Content (%)	5.50	4.75	805.4	34.0	66.0	
		2.36	1345.3	56.8	43.2	
		600 μ m	1700.5	71.8	28.2	
		300	1898.7	80.2	19.8	
		150	2088.6	88.2	11.8	
Characteristic of recovered Asphalt			75	2162.6	91.4	8.6
Penetration (1/10mm)	34	Total				
Softening Point ()	58.6

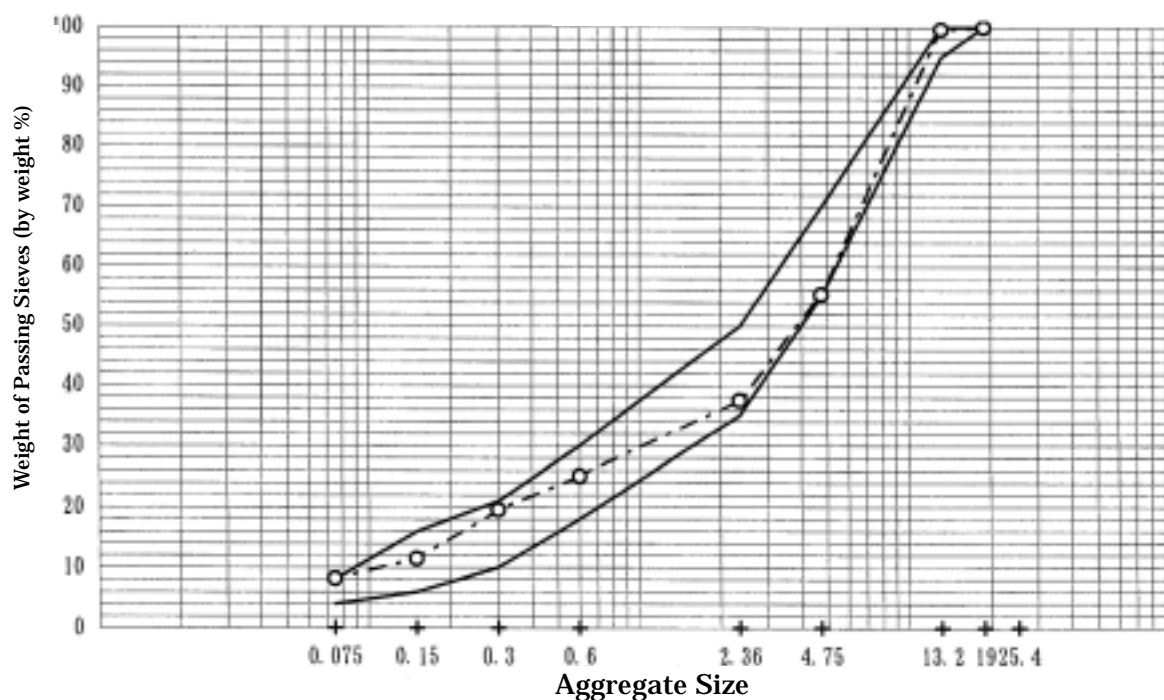
Grading Curves

Manual for Asphalt Pavement		Results of Abson Extraction Test	
Coring Spot	Job Site #2, Ohgishima Plant Road, NKK	Inspected date	Dec.17 2001
Type of Mix	Dense-graded Asphalt Concrete (13)	Inspector	Yoshinaka Shiga

Asphalt Content (%)			Sieving Analysis			
Weight of a Sample (g)	2062.5	Sieving Size	Accumulated Residual (g)	Accumulated Residual (%)	Passing (%)	
Weight of Extracted Aggregate (g)	1957.5	25 . 4mm				
Weight of Asphalt (g)	105.0	19 . 0	0	0	100	
Extracted Asphalt Content (%)	5.09	13.2	7.2	0.4	99.6	
Designed Asphalt Content (%)	5.30	4.75	874.4	44.7	55.3	
		2.36	1223.4	62.5	37.5	
		600 μ m	1466.3	74.9	25.1	
		300	1574.6	80.4	19.6	
Characteristic of recovered Asphalt			150	1733.7	88.6	11.4
Penetration (1/10mm)	37	75	1797.4	91.8	8.2	
Softening Point ()	58.7	Total

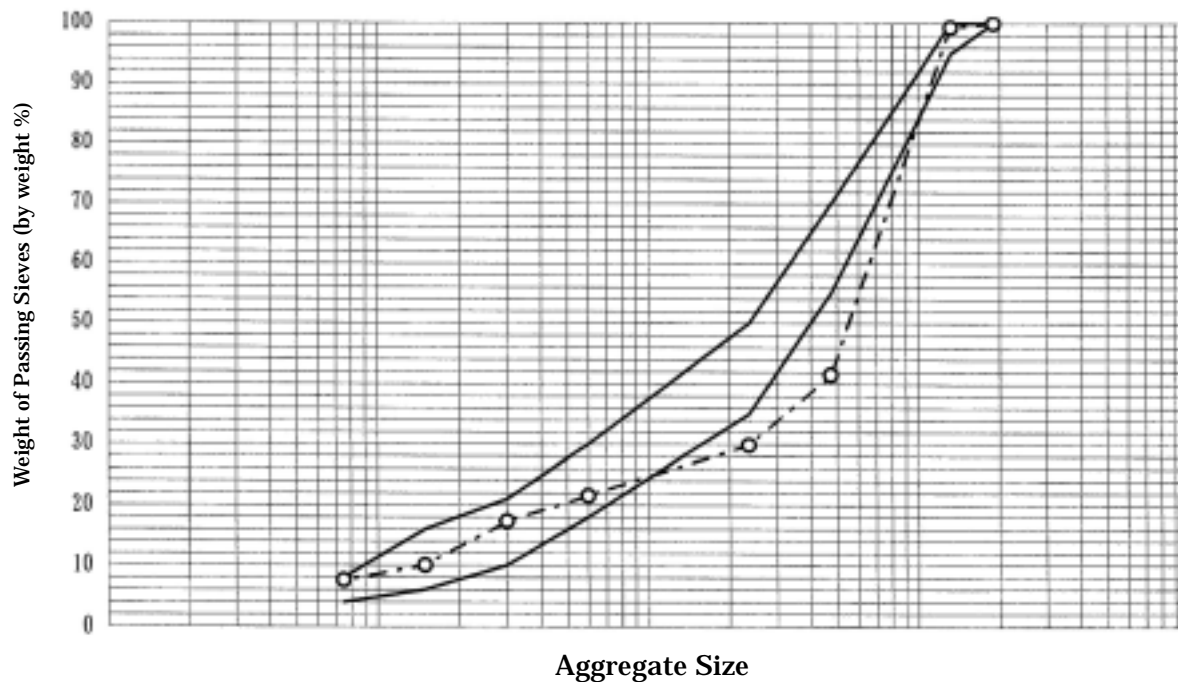
Grading Curves

Manual for Asphalt Pavement	Results of Abson Extraction Test		
Coring Spot	Aggregate Scattering Spots, Ohgishima Plant Road, NKK	Inspected date	Dec.17 2001
Type of Mix	Dense-graded Asphalt Concrete (13)	Inspector	Yoshinaka Shiga

Asphalt Content (%)			Sieving Analysis			
Weight of a Sample (g)	2462.0	Sieving Size	Accumulated Residual (g)	Accumulated Residual (%)	Passing (%)	
Weight of Extracted Aggregate (g)	2363.5	25 . 4mm				
Weight of Asphalt (g)	98.5	19 . 0	0	0	100	
Extracted Asphalt Content (%)	4.00	13.2	16.8	0.7	99.3	
Designed Asphalt Content (%)	5.30	4.75	1381.2	58.4	41.6	
		2.36	1658.3	70.2	29.8	
		600 μ m	1854.3	78.5	21.5	
		300	1954.8	82.7	17.3	
Characteristic of recovered Asphalt			150	2127.5	90.0	10.0
Penetration (1/10mm)	22	75	2185.2	92.5	7.5	
Softening Point ()	65.8	Total

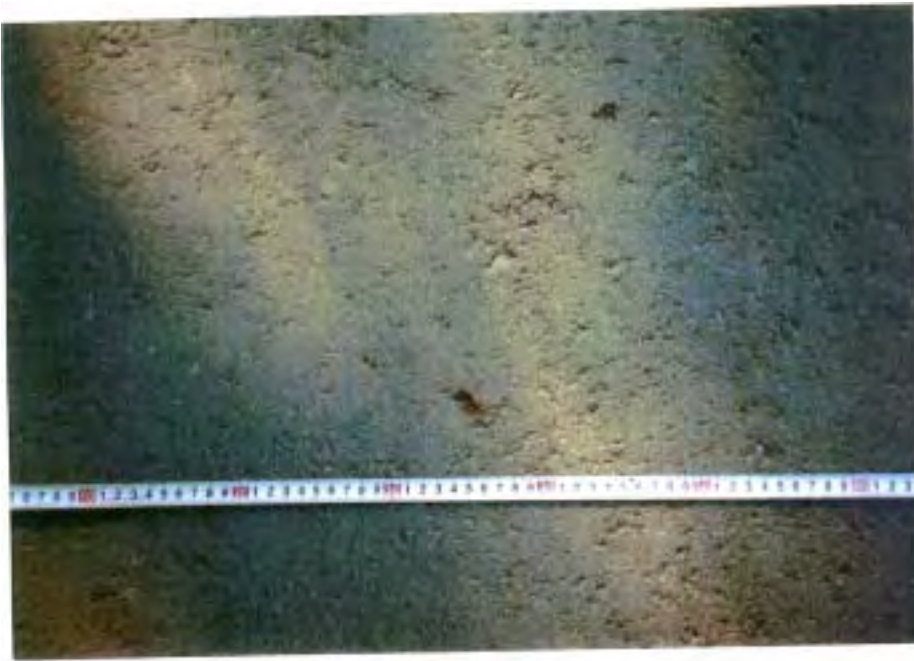
Close up of Road Surface
(Job Site #1)

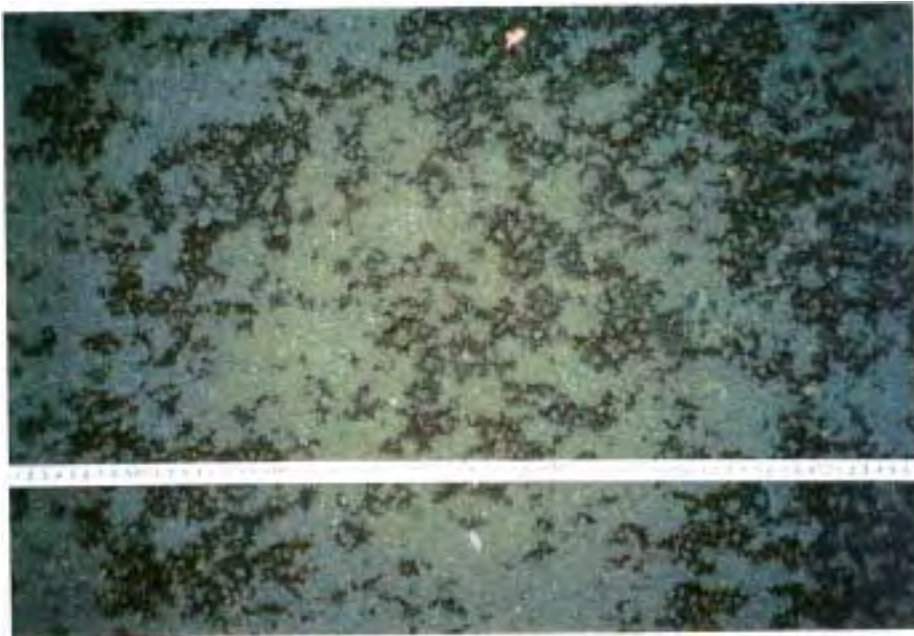
Close up of Road Surface
(Job Site #1)

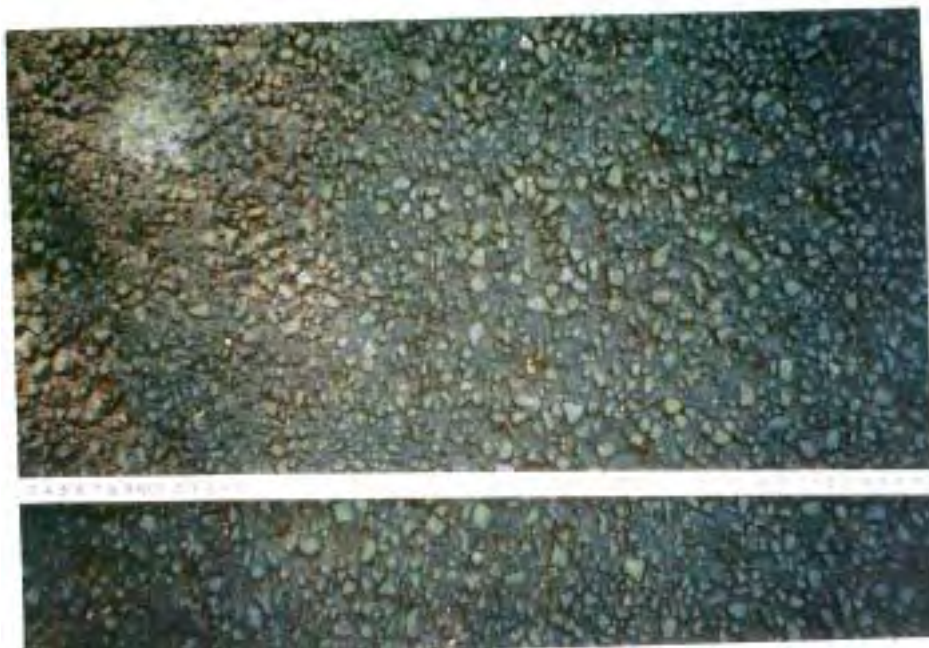
Close up of Road Surface
(Aggregate Scattering Spots)

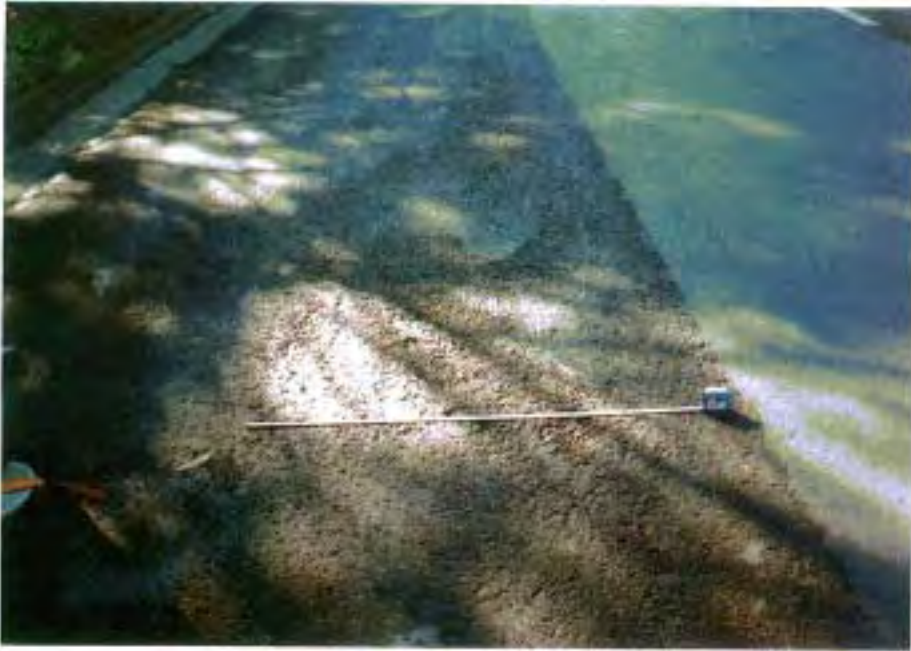
Aggregate Scattering Spots

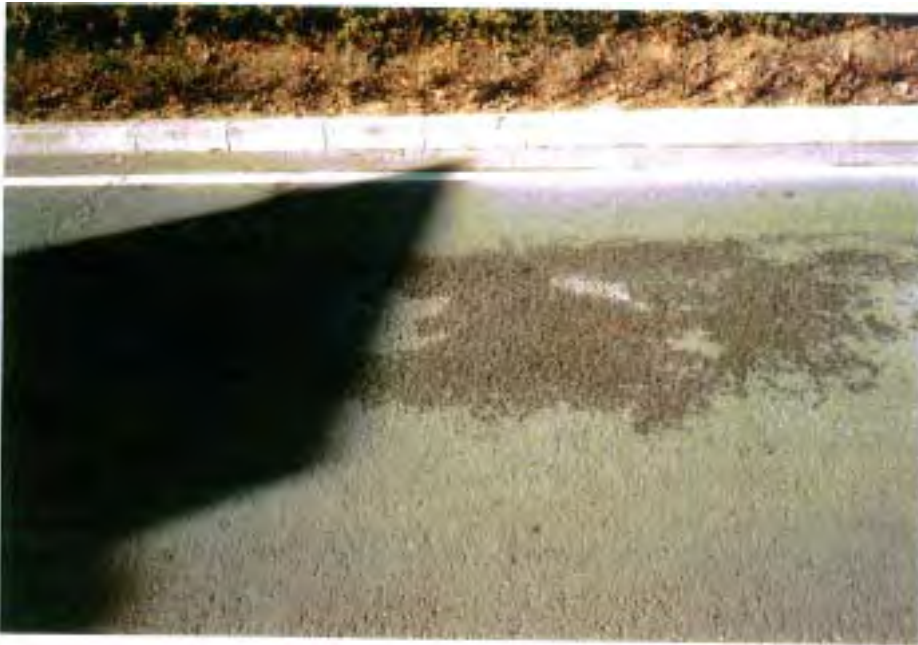
Aggregate Scattering Spots
End of Inspected
Opposite Lane
